**HIDDEN LAKE DAM**

(NDS-ID-PA-1136)

**PHASE I INSPECTION REPORT  
NATIONAL DAM INSPECTION PROGRAM**

PHASE I  
NATIONAL DAM INSPECTION PROGRAM  
HIDDEN LAKE DAM  
NDI. I.D. NO. PA 1136  
DER I.D. NO. 40-228

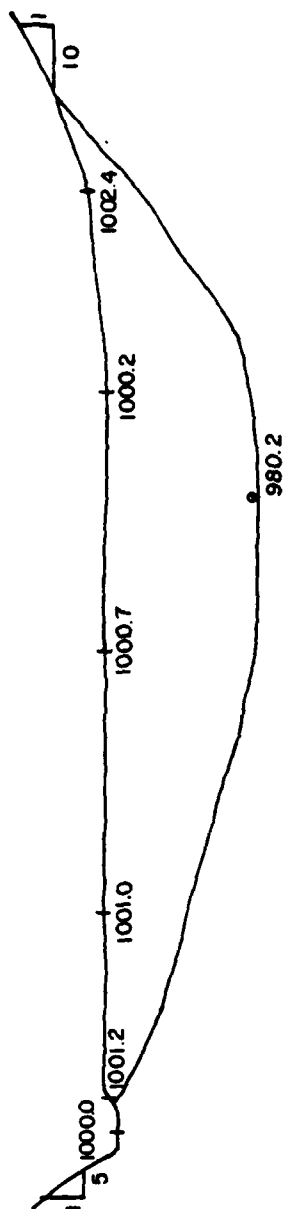
PROFILE  
LOOKING UPSTREAM  
Scale: Horiz. 1" = 100'  
Vert. 1" = 20'

A low spot was observed on the embankment crest 160 feet from the left abutment.
